**Flood Control Project Maintenance
Levee Inspections**
LMA District Cover Sheet
Spring 2014 Levee Inspection Results

Reclamation District No. 0524 Middle Roberts Island

Spring 2014 Levee Inspection Results

| Waterway | | | Bank | Unit Miles |
|--|---|---|---|---|
| Unit No. 01 San Joaquin River | | | Left | 6.26 |

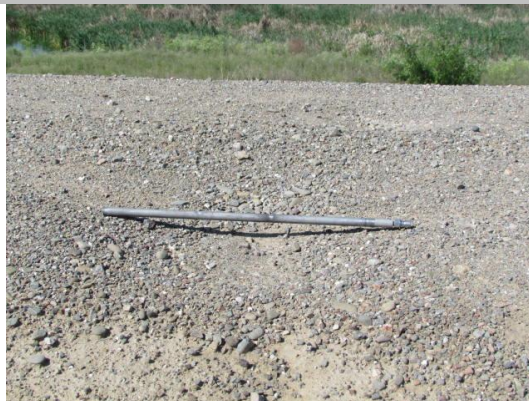
Photo 1 of 3 : richard_s_20140320_107.jpg

Looking west at 3" depression on levee crown. (Spring 2012)

| Repair depressions or ruts in the crown or slope. | | | | | |

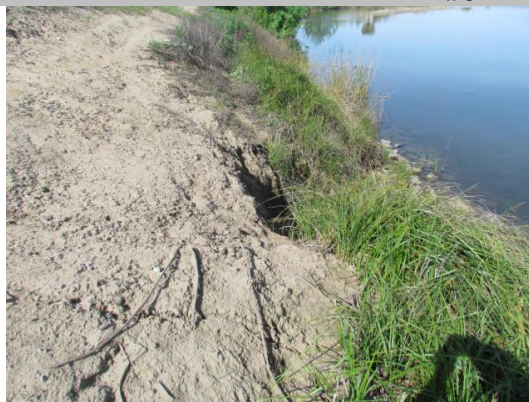
Photo 1 of 2 : richard_s_20140411_518.jpg

| Schedule repair of erosion site prior to the next inspection. Inspector Comments: Erosion is located along the lower level of waterward slope. | | | | | |

Looking northeast at erosion on waterward toe.

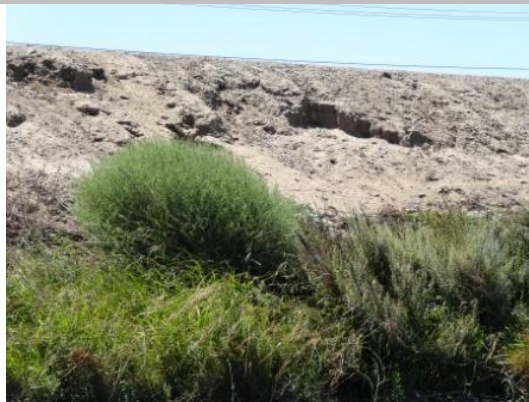
Photo 1 of 1 : richard_s_20140320_111.jpg

| Inspector Comments: 08/13/2013: No significant change at this site. 8/7/2012: Erosion is at the upper levee slope, and likely caused by slope slip. The lower levee slope is covered with dense vegetation. [2013 Site ID:RD0524U01RM40.99]. Item has been corrected and should be removed from the list. | | | | | |

Front view of erosion site. Note the vegetation at the levee toe and lower slope.

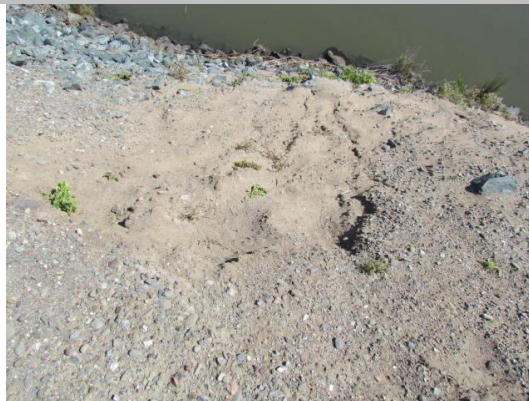
Photo 1 of 1 : richard_s_20140320_113.jpg

Looking east at waterside erosion appears to be caused by runoff.

| Repair the levee slope damaged by foot traffic and prevent access | | | | | |

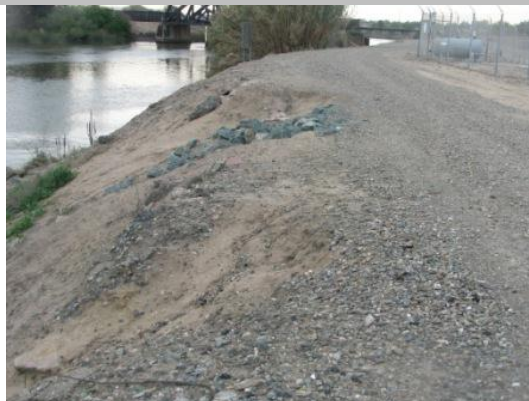
Photo 1 of 3 : richard_s_20140320_118.jpg

Erosion from LM 0.65 to 0.66

| Repair slope instability. | | | | | |

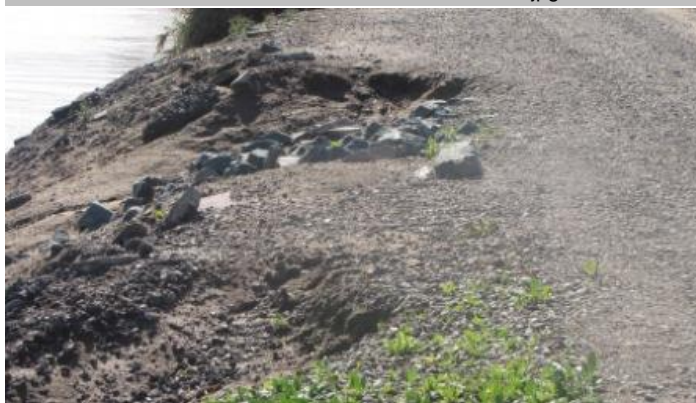
Photo 3 of 3 : richard_s_20140320_120.jpg

Looking south at erosion on waterside shoulder.

| Repair slope instability. | | | | | |

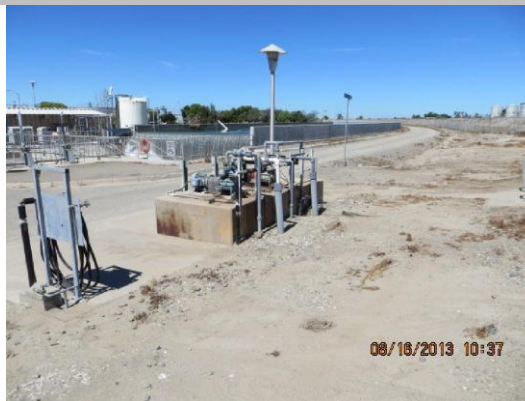
Photo 1 of 1 : UCIP_1614.jpg

Vacuum pumps off LS toe.

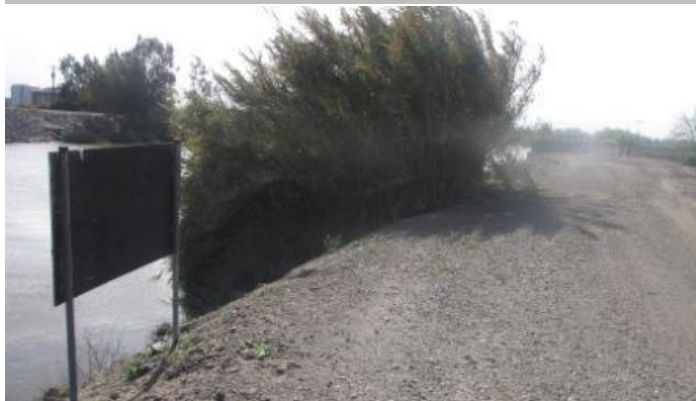
Photo 1 of 3 : richard_s_20140320_121.jpg

Looking southeast at bamboo on waterside shoulder as of 4/2010.

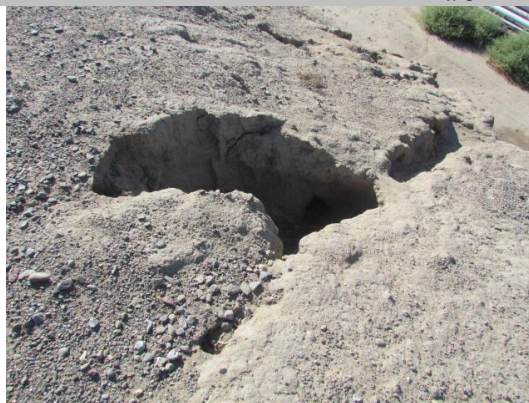
Photo 1 of 5 : richard_s_20140320_102.jpg

| Schedule repair of erosion site prior to the next inspection. Inspector Comments: Several holes and finger erosions on landward slope. | | | | | |

Looking southwest at hole on landward shoulder.

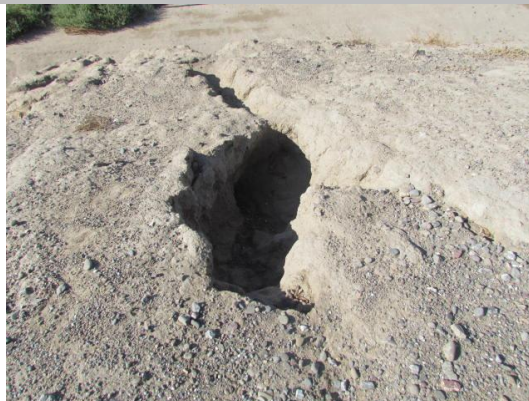
Photo 2 of 5 : richard_s_20140320_103.jpg

| Schedule repair of erosion site prior to the next inspection. Inspector Comments: Several holes and finger erosions on landward slope. | | | | | |

Looking west at hole on landward shoulder.

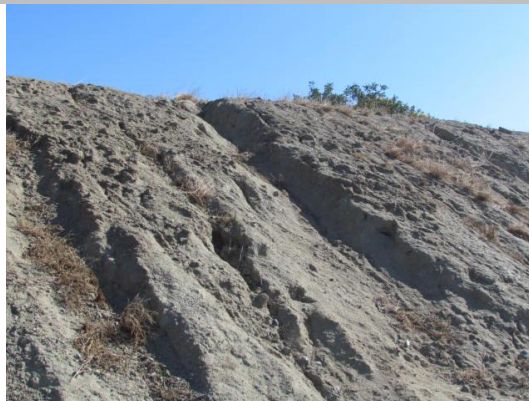
Photo 5 of 5 : richard_s_20140320_106.jpg

Looking southeast at finger erosion on landward slope.

| Schedule repair of erosion site prior to the next inspection. | | | | | | |

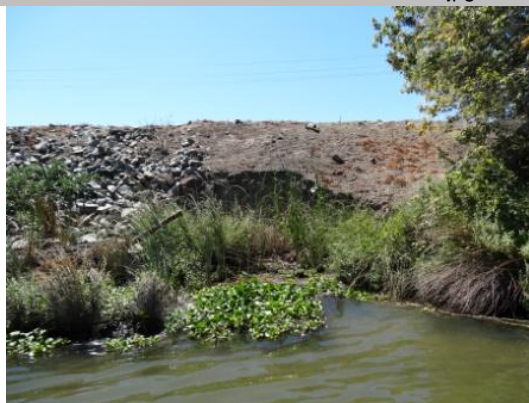
Photo 1 of 1 : richard_s_20140320_187.jpg

| Inspector Comments: 08/13/2013: No significant change at this site. 08/07/2012: The site has been visited by boat survey. No significant change observed 08/23/2011: The erosion site is immediately downstream of the riprap protection. [2013 Site ID:RD0524U01RM41.5] | | | | | |

Front view of the erosion. Note the riprap protection near the site.

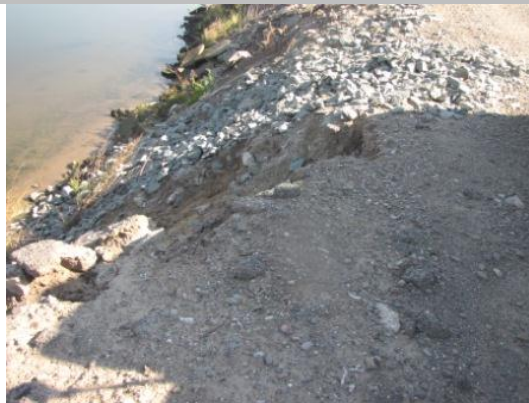
Photo 1 of 3 : richard_s_20140320_125.jpg

| Schedule repair of erosion site prior to the next inspection. Inspector Comments: Minor erosion was noted next to repaired site. | | | | | |

Looking upstream (south) at erosion site.

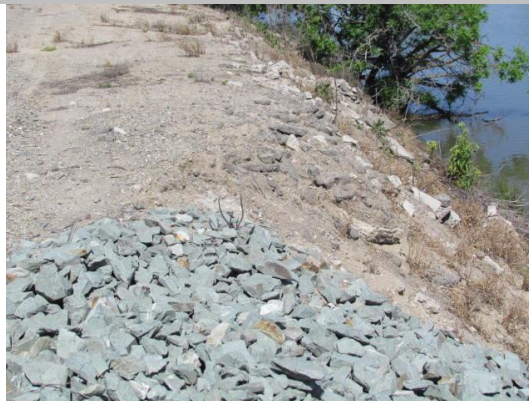
Photo 2 of 3 : richard_s_20140320_126.jpg

Looking north at erosion site next to repaired site. (Spring 2012)

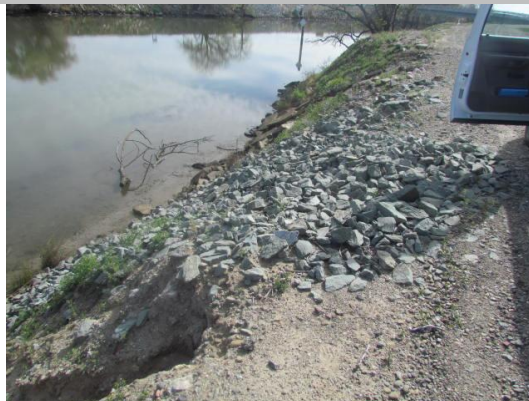
Photo 3 of 3 : richard_s_20140320_127.jpg

Looking southeast at erosion next to repaired site on waterward slope
(Spring 2013)

| Schedule repair of erosion site prior to the next inspection. | | | | | | | |

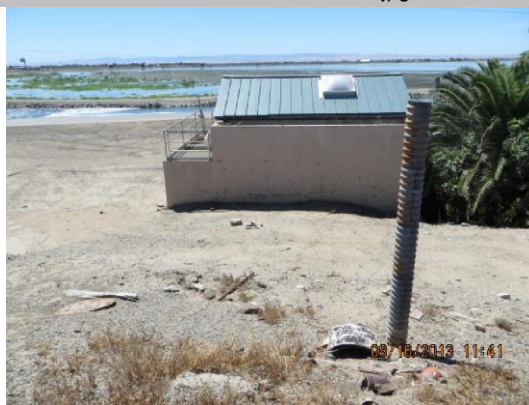
Photo 1 of 1 : UCIP_1710.jpg

| UCIP Comments: Given amount of rust on adjacent CMP riser, it may be appropriate to do a video inspection of this pipe. | | | | | |

8-inch CMP standpipe on LS slope with pumphouse in background.

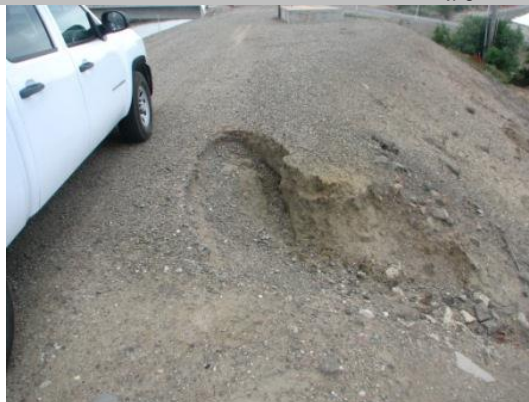
Photo 1 of 5 : richard_s_20140320_128.jpg

Landward slope damage at LM 1.09.

| Repair slope instability. | | | | | |

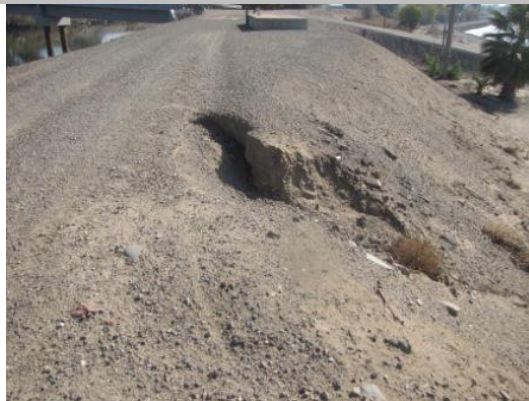
Photo 2 of 5 : richard_s_20140320_129.jpg

Updated picture of the erosion site on the landside shoulder.

| Repair slope instability. | | | | | |

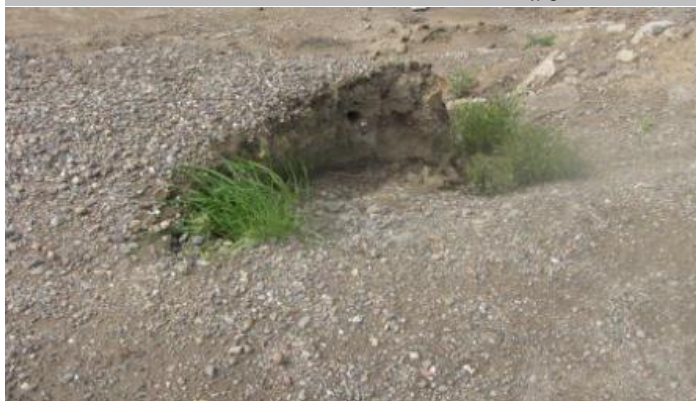
Photo 3 of 5 : richard_s_20140320_130.jpg

Updated view from above the slope stability.

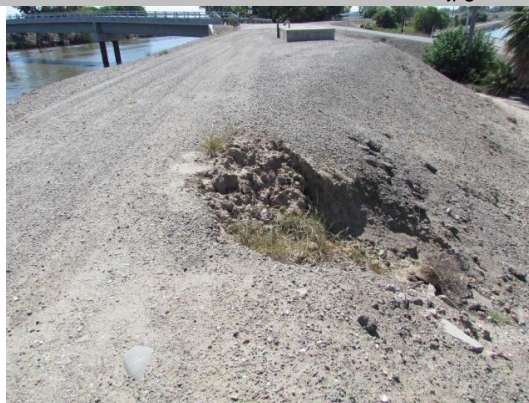
Photo 5 of 5 : richard_s_20140320_132.jpg

Looking south at caving on landside shoulder. (Spring 2012)

| Repair slope instability. | | | | | | |

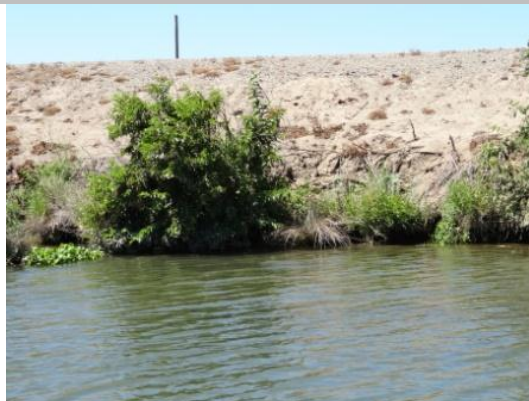
Photo 1 of 1 : richard_s_20140320_218.jpg

| Inspector Comments: 08/13/2013: No significant change at this site. 08/07/2012: The site has been visited by boat survey. No significant changes observed 08/23/2011: No significant changes observed on site. 9/07/2010: No significant changes observed on site. Vegetation is visible at the water line. There is an exposed pipe discharge partially hanging at the mid-slope, possibly still used for discharging irrigation/runoff water. There is minimal rip rap protection along the bank, and what's left of it is no longer adequately protecting the bank. 9/29/2009: Site consists of a 400-foot long eroding bank with minimal vegetation and protection; the existing rip rap has sloughed, rendering it useless; note that there is an exposed section of a pipe. 10/18/2006: There is extensive loss of rip rap on some sections; sewage disposal pond is on the landside of the levee; there is an exposed pipe outlet "hanging" from the upper slope. [2013 Site ID:RD0524U01RM41.79] | | | | | |

Direct view of the site.

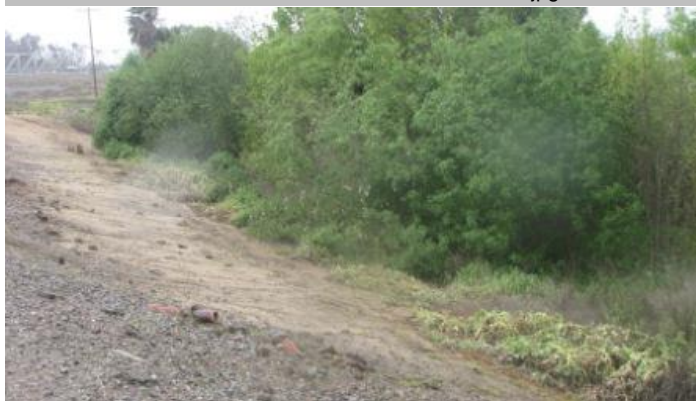
Photo 1 of 1 : richard_s_20140320_246.jpg

Looking southwest at dense veg. on landside toe.

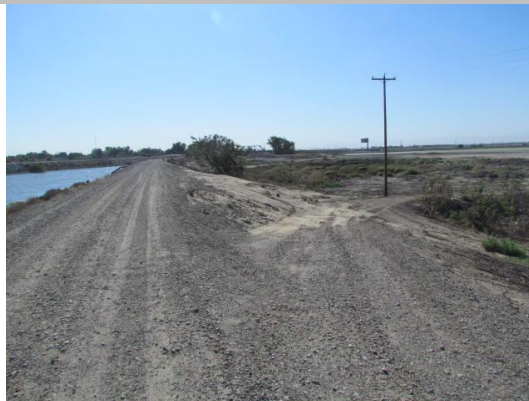
Photo 1 of 2 : richard_s_20140320_239.jpg

| Inspector Comments: Unauthorized ramps on landside slope. Ramps were caused by vehicle traffic. | | | | | |

Looking south at unauthorized ramp on landside slope.

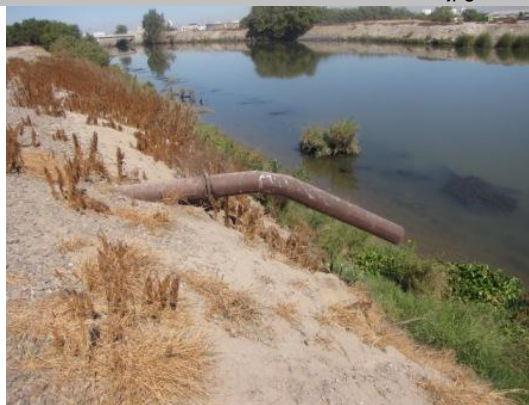
Photo 1 of 2 : richard_s_20140320_143.jpg

Looking north at broken pipe.

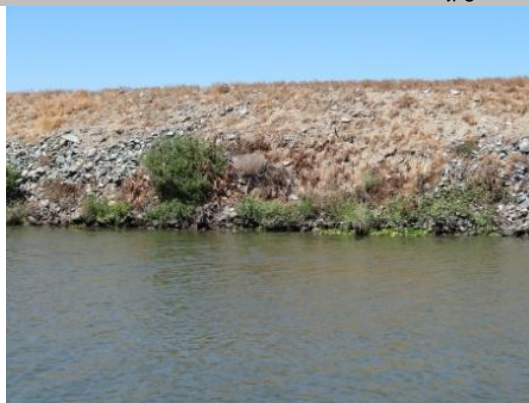
Photo 1 of 1 : richard_s_20140320_220.jpg

| Inspector Comments: 08/13/2013: No significant change observed. 08/07/2012: The site was first reported in 2012 spring levee inspection report. The site is located about 750 ft downstream of SR 4 Bridge. [2013 Site ID:RD0524U01RM42.03] | | | | | |

Front view of the erosion.

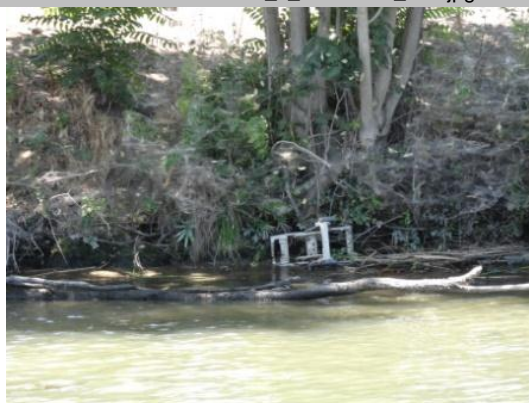
Photo 1 of 1 : richard_s_20140320_222.jpg

| Inspector Comments: 08/13/2013: No significant change observed. 08/07/2012: : The site has been visited by boat survey. No significant change observed 08/23/2011: No significant changes observed on site. Trees concerned still in place. 09/07/2010: No significant changes observed on site. The concern here is the undermining of the levee toe where most of trees are. There are erosion pockets lined along the lower slope and at the base of the trees, exposing tree roots. There is minimal slope protection. 09/29/2009: The lower slope is lined with minor erosion pockets; some tree roots are exposed; there is visible undermining of the levee toe; site is immediately upstream of the Highway 4 Bridge; the bridge is possibly causing a scour to occur, eroding the bank. [2013 Site ID:RD0524U01RM42.2] | | | | | |

Front view of erosion. Dense vegetation is visible.

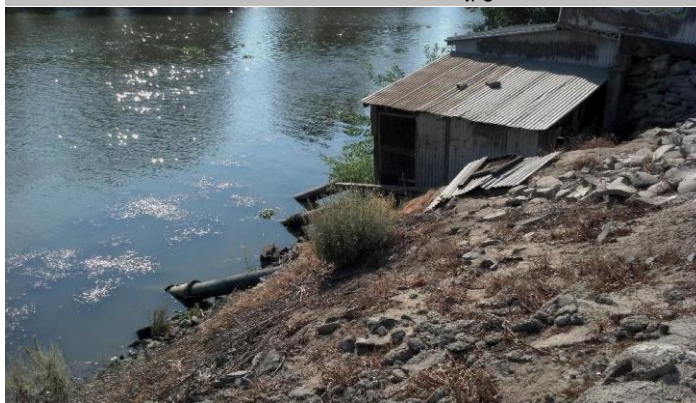
Photo 1 of 1 : UCIP_1631.jpg

Inspector Comments: FS_ID:17847
 EP_NO: N/A
 Repair Type:
 Crossing Status:
 UCIP Comments: Pipe appears abandoned and if so should be done so properly.
 FIELD_STRUCT_DESC: 14-inch pipe through levee 20.0 feet below crown, 2 pumps and gate valves discharge into surge tank in pump house on the waterward slope. Concrete distribution box removed from the waterward slope. Abandoned 36-inch diameter concrete standpipe on LS toe next to service pole. Originally included in the 1964 O&M manual.
 FS Date: 8/20/2013

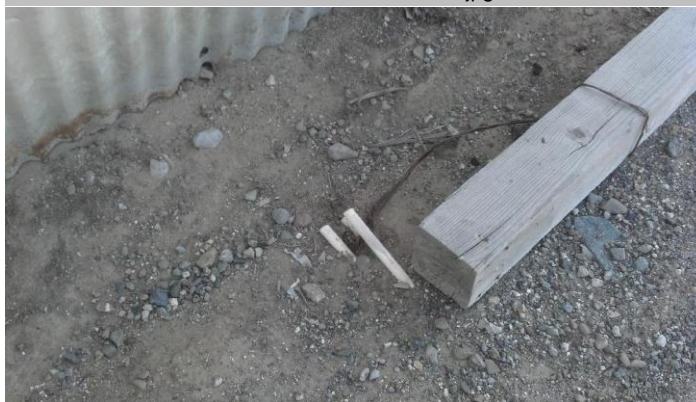
Photo 1 of 1 : UCIP_2773.jpg

Inspector Comments: FS_ID:21865
 EP_NO: N/A
 Repair Type:
 Crossing Status:
 UCIP Comments: Pipes appear abandoned and should be removed from levee.
 FIELD_STRUCT_DESC: One 1-inch and two 3/4-inch PVC conduits through the levee 6-inches below the crown.
 FS Date: 8/20/2013

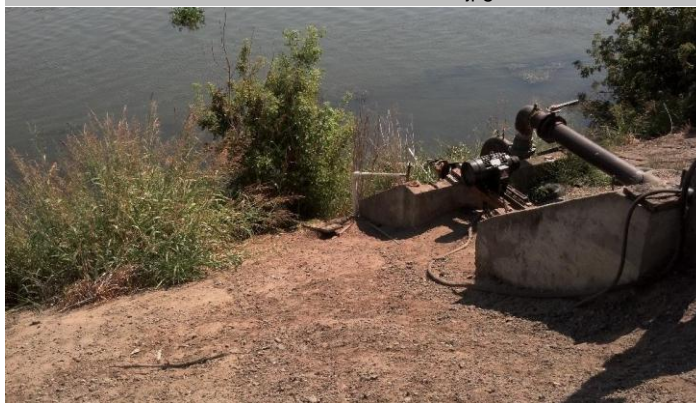
Photo 1 of 1 : UCIP_2778.jpg

Pump and pipe visible on WS slope.

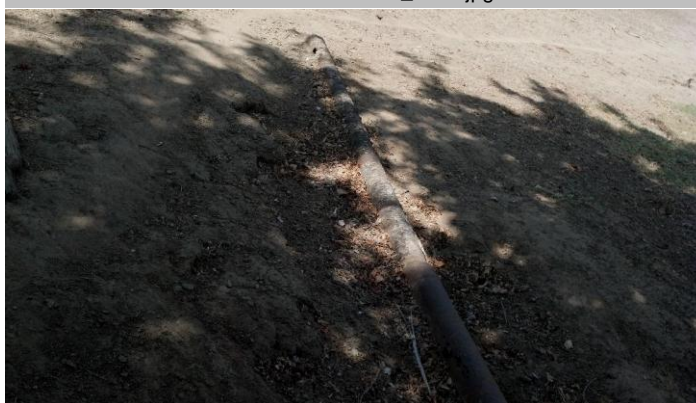
Photo 1 of 1 : UCIP_2783.jpg

Pipe visible on WS slope.

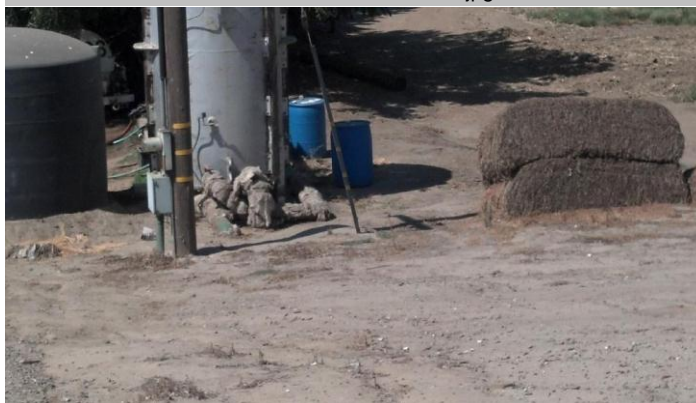
Photo 1 of 1 : UCIP_2786.jpg

Steel irrigation line visible in front of tank to right of powerpole off LS toe.

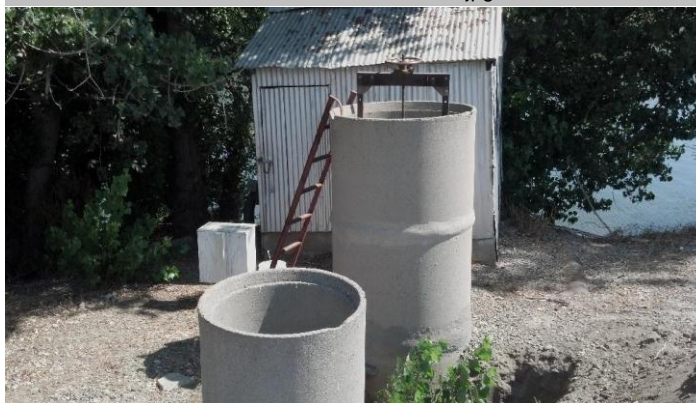
Photo 1 of 1 : UCIP_1635.jpg

| UCIP Comments: Soil excavated from cover over pipe on WS next to concrete riser. May indicate a leak or other problem. | | | | | |

Slide gate in concrete riser with secondary concrete riser in foreground. Pumphouse in background.

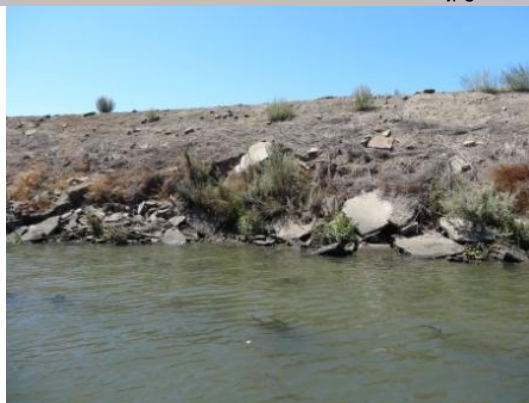
Photo 1 of 1 : richard_s_20140320_223.jpg

| Inspector Comments: 08/13/2013: No significant change observed. Slightly more vegetation was visible. 08/07/2012: The site was first reported in 2012 spring levee inspection report. [2013 Site ID:RD0524U01RM42.79] | | | | | |

Looking from downstream.

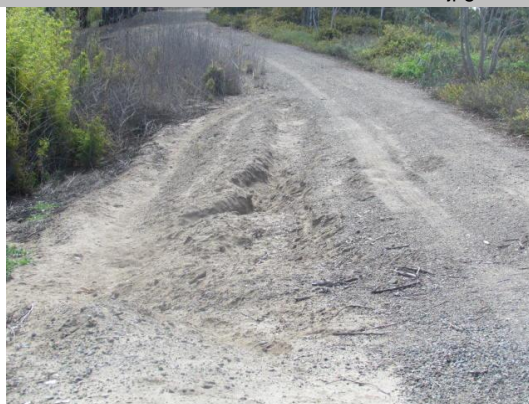
Photo 1 of 1 : richard_s_20140320_141.jpg

Looking south slope damage on waterward shoulder and slope.

| Repair slope instability. | | | | | |

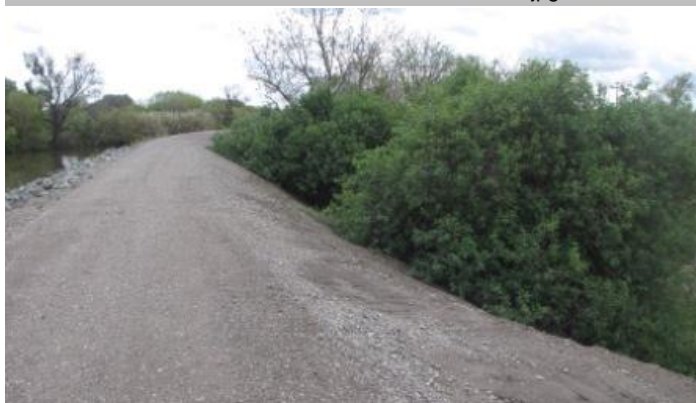
Photo 1 of 1 : richard_s_20140320_142.jpg

Looking south at dense veg on landside slope and toe.

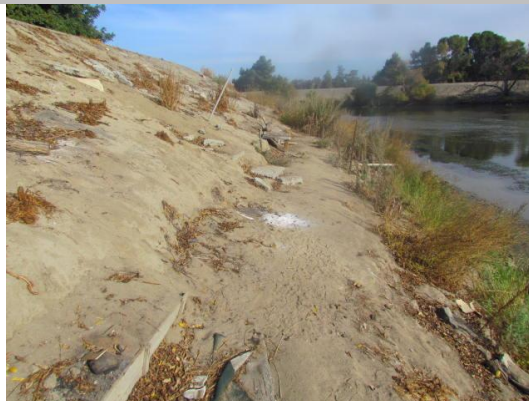
Photo 1 of 1 : richard_s_20140320_145.jpg

| Repair the levee slope damaged by foot traffic and prevent access where possible. Inspector Comments: Slope damage caused by walking traffic and using bank as a fishing platform. | | | | | |

Looking northeast at damage to the slope possibly caused by human activity.

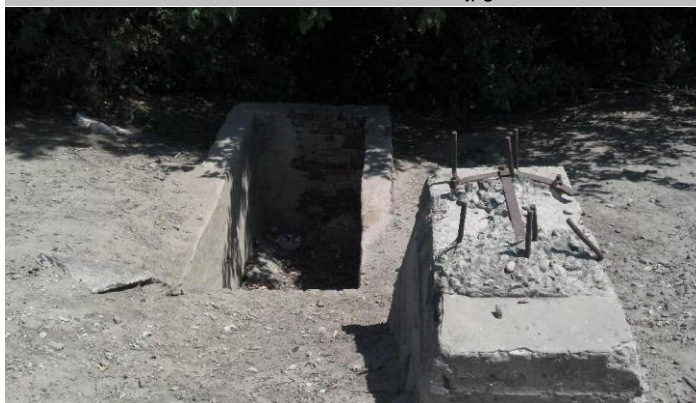
Photo 1 of 1 : UCIP_2789.jpg

Foundation for pump with distribution box on WS shoulder.

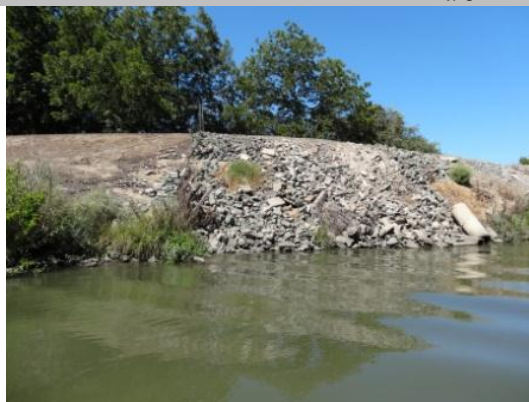
Photo 1 of 1 : richard_s_20140320_226.jpg

Upstream view of erosion. Levee slope protection present upstream of the site.

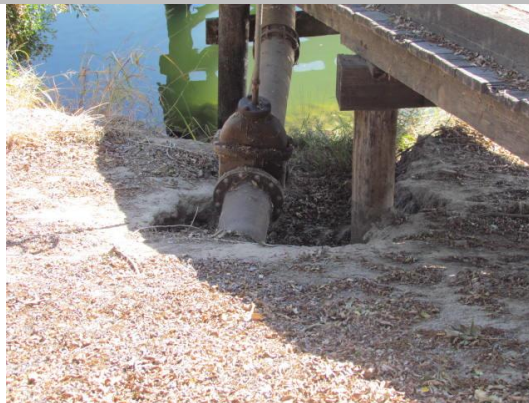
Photo 1 of 2 : richard_s_20140320_134.jpg

Looking east at erosion around irrigation pipe on waterward slope.

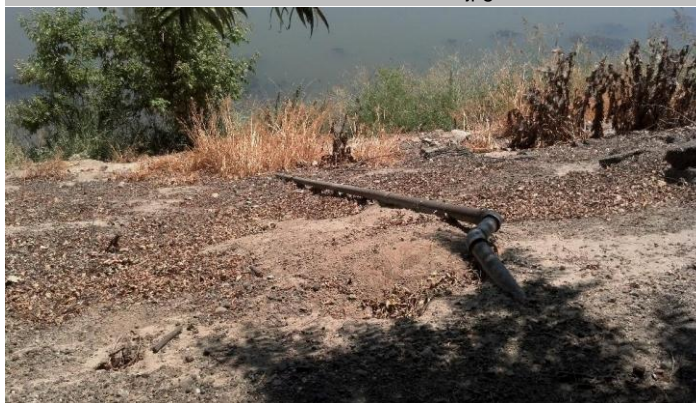
Photo 1 of 1 : UCIP_1644.jpg

Pipe visible on WS slope.

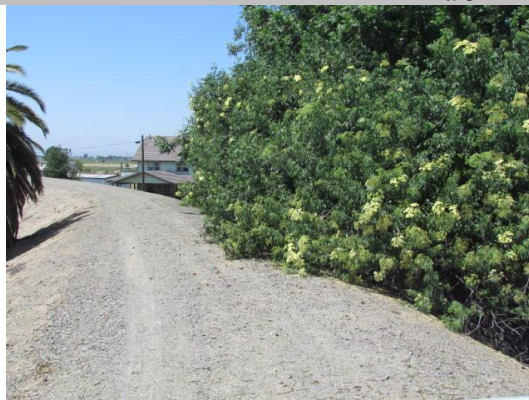
Photo 2 of 2 : richard_s_20140320_164.jpg

Looking south at dense elderberry on landside slope.(Spring 2012)

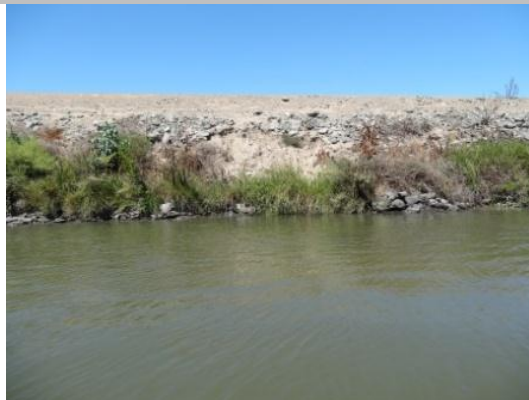
Photo 1 of 1 : richard_s_20140320_228.jpg

Front view of erosion.

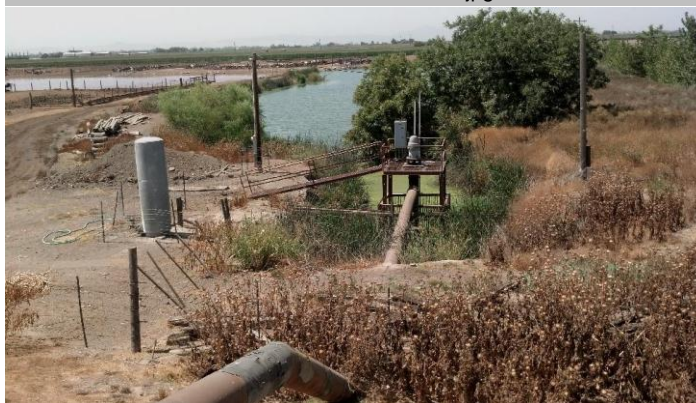
Photo 1 of 1 : UCIP_1646.jpg

Pipe, pump, power pole, and meter visible off LS toe.

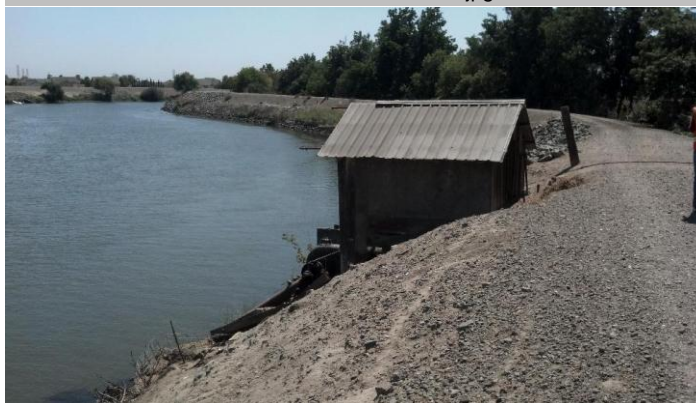
Photo 1 of 1 : UCIP_1650.jpg

Pipe and pumphouse on WS slope.

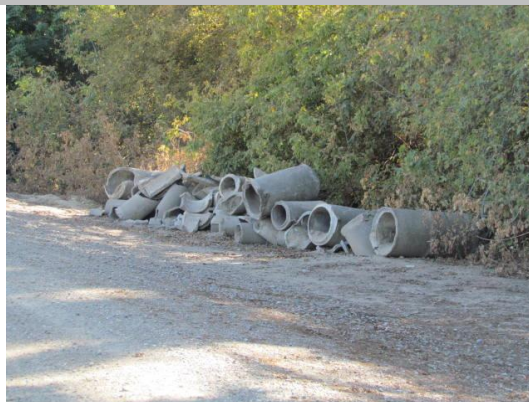
Photo 1 of 1 : richard_s_20140320_169.jpg

Looking southwest at concrete pipes on landside toe.

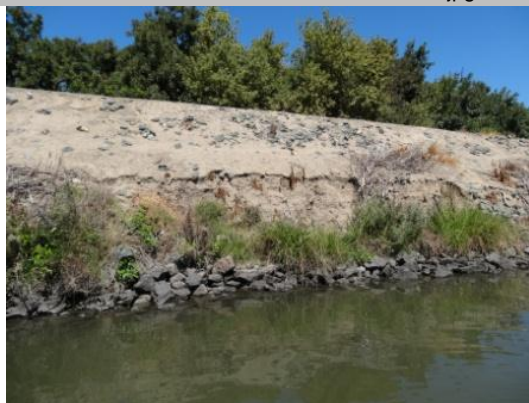
Photo 1 of 1 : richard_s_20140320_230.jpg

Front view of erosion.

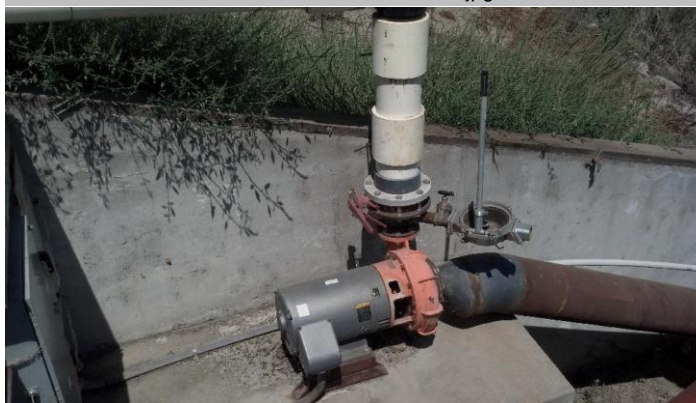
Photo 1 of 1 : UCIP_3049.jpg

Pump and butterfly valve on concrete pad on WS shoulder.

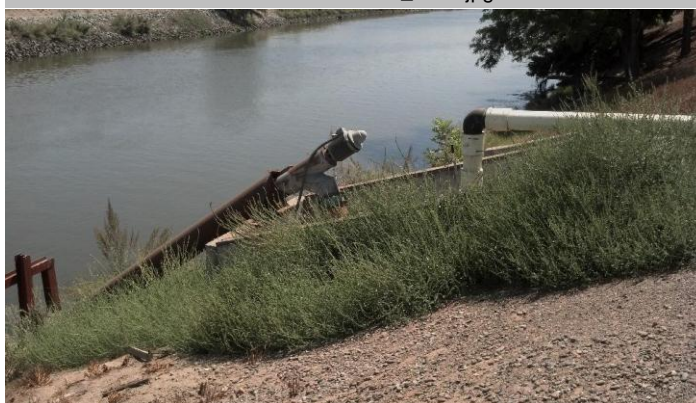
Photo 1 of 1 : UCIP_1654.jpg

Slant pump visible at concrete foundation on WS slope. Pumphouse removed.

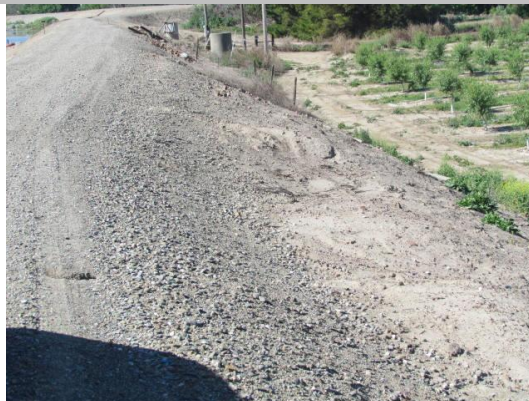
Photo 1 of 1 : richard_s_20140320_201.jpg

Looking southwest at caving slope on landside of levee.

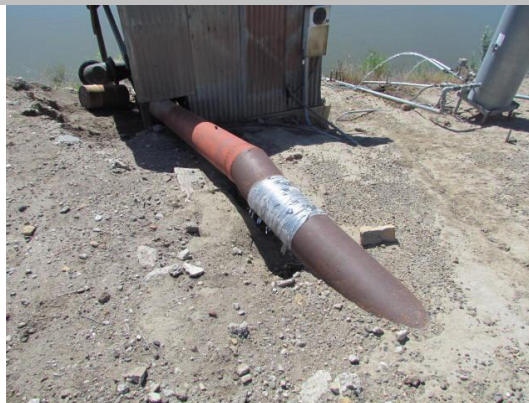
Photo 1 of 4 : richard_s_20140320_202.jpg

Looking east at damaged pipe on waterside slope. (Spring 2012)

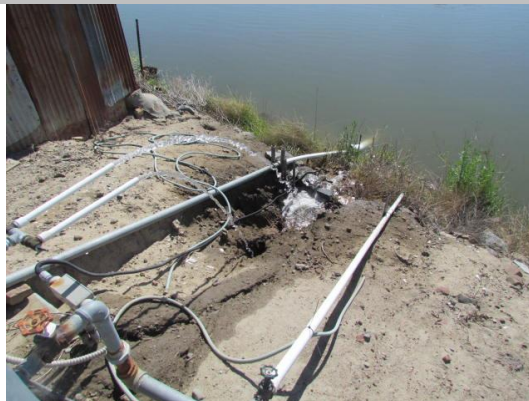
Photo 2 of 4 : richard_s_20140320_203.jpg

Looking east at irrigation system damaging waterside toe.

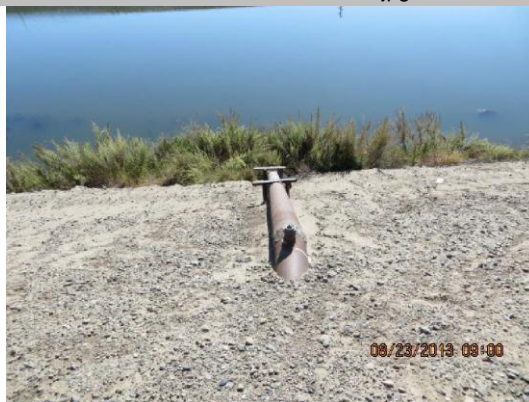
Photo 1 of 1 : UCIP_1669.jpg

Pipe and siphon breaker on WS slope.

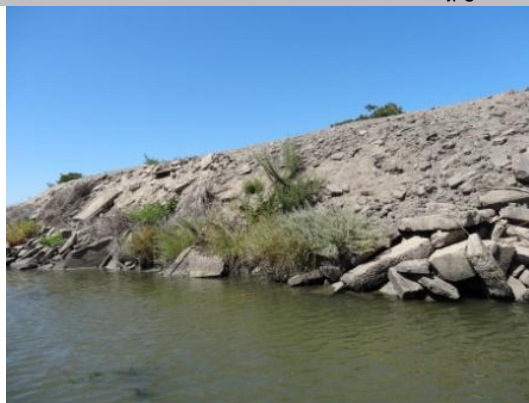
Photo 1 of 1 : richard_s_20140320_231.jpg

Upstream view of erosion site.

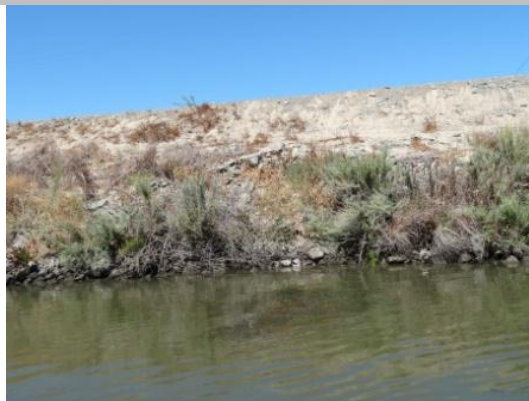
Photo 1 of 1 : richard_s_20140320_232.jpg

Front view of the erosion.

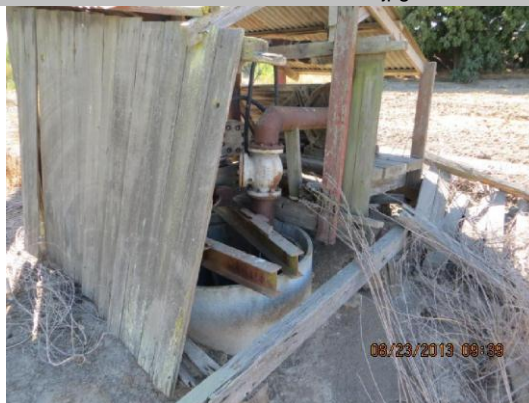
Photo 1 of 1 : UCIP_3054.jpg

Pump over sump 120-feet off LS toe at end of drainage channel.

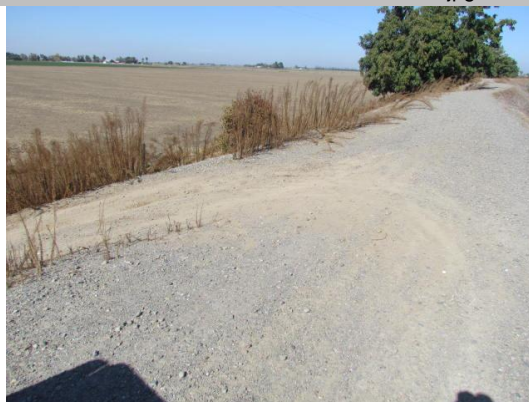
Photo 1 of 1 : richard_s_20140320_209.jpg

Looking northwest at slope damage on landward slope.

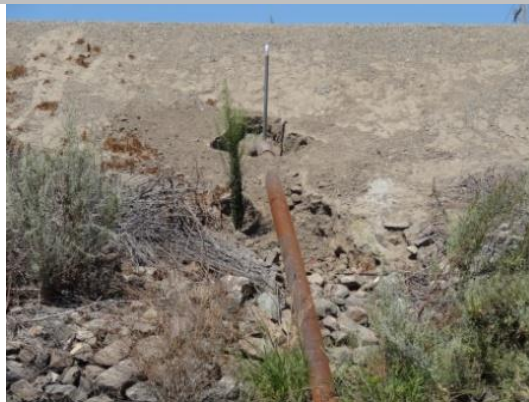
Photo 1 of 1 : richard_s_20140320_235.jpg

Front view of the site.

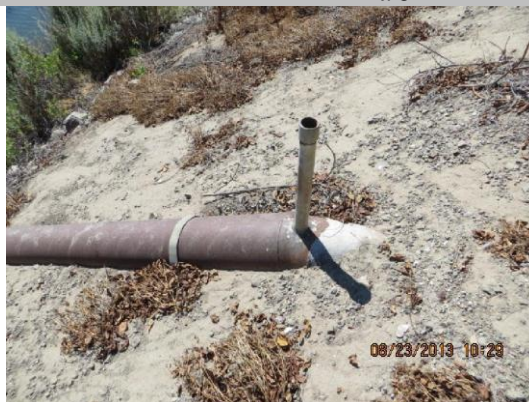
Photo 1 of 1 : UCIP_1677.jpg

Vent on pipe on WS slope. Possible slurry standpipe that has not yet been used.

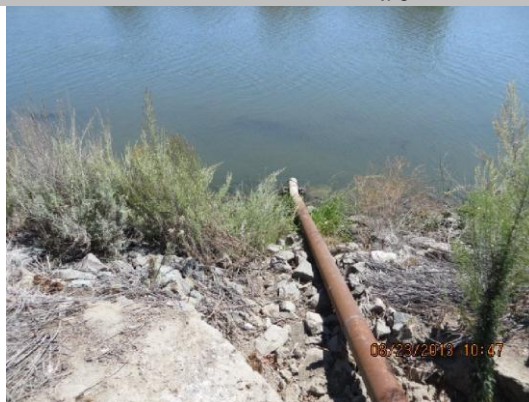
Photo 1 of 1 : UCIP_1679.jpg

No flap gate on end of pipe at WS toe.

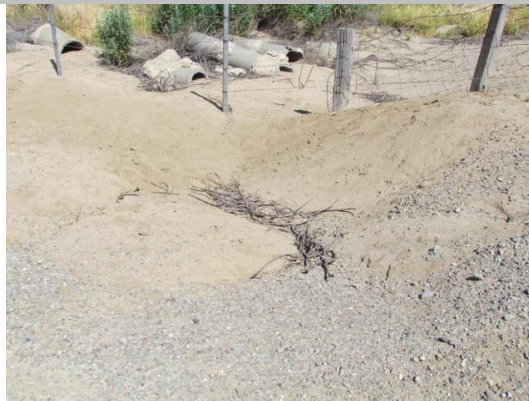
Photo 1 of 3 : richard_s_20140320_210.jpg

Looking west at slope damage on landside slope.

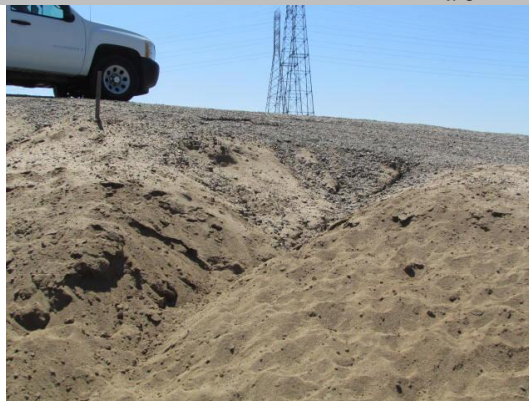
Photo 3 of 3 : richard_s_20140320_212.jpg

Looking southeast at damaged slope.

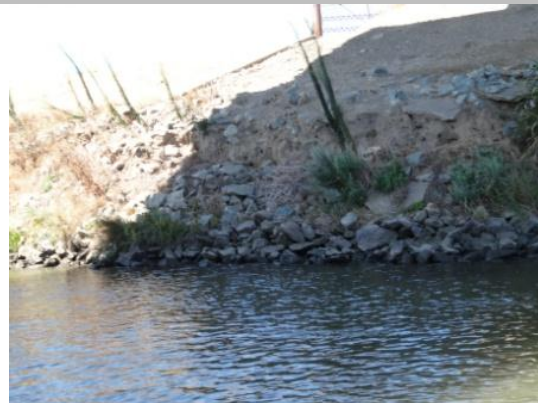
Photo 1 of 1 : richard_s_20140320_233.jpg

Sloughing rip rap adjacent to Howard Bridge.

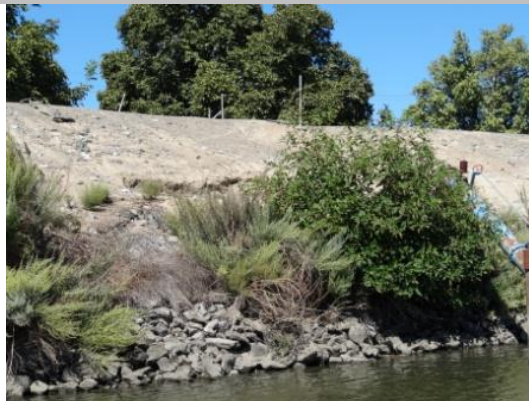
Photo 1 of 1 : richard_s_20140320_234.jpg

Closer view of the erosion.

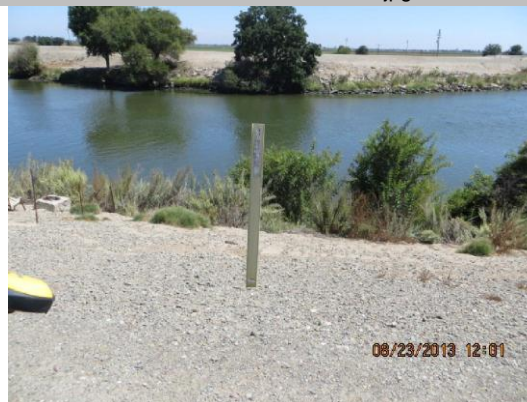
Photo 1 of 1 : UCIP_1711.jpg

Gasline marker on WS shoulder.

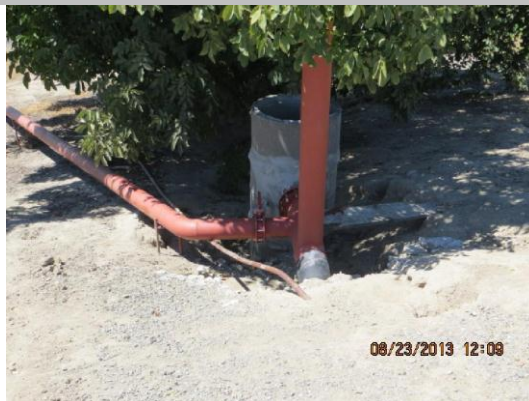
Photo 1 of 1 : UCIP_1689.jpg

Butterfly valves and standpipes on LS slope along with electrical conduit.

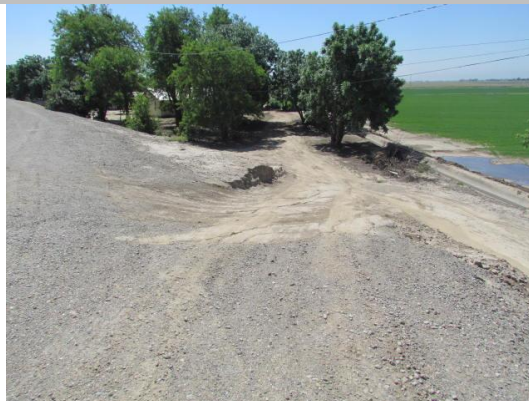
Photo 1 of 2 : richard_s_20140320_213.jpg

Looking southwest at damaged slope and ramp on landside slope.

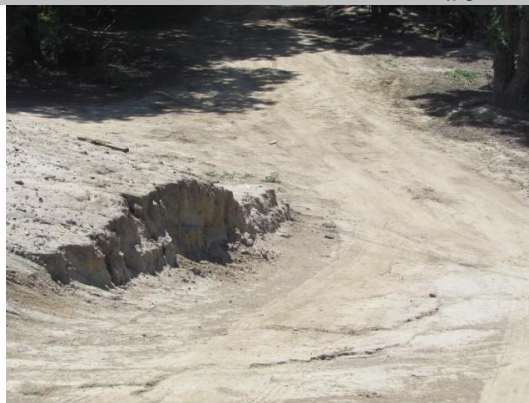
Photo 2 of 2 : richard_s_20140320_214.jpg

Looking west at unauthorized ramp and landside slope damage.

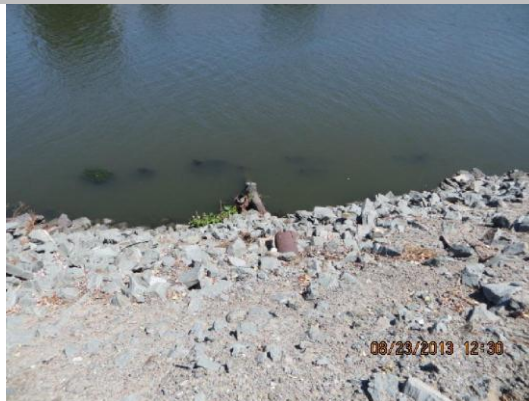
Photo 1 of 1 : UCIP_1694.jpg

Pump and open pipe visible on WS slope.

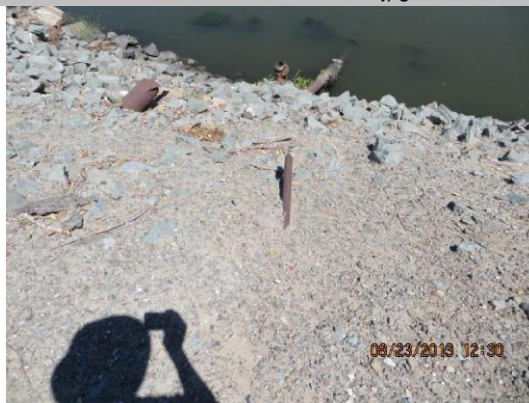
Photo 1 of 1 : UCIP_2819.jpg

Pipe visible on WS slope.
